# Diagnostic Investigation of Hydro Electric Project Made Easy with Remote Operated Vehicle

#### 3.1. Underwater Scanning of Hirakud Dam Using ROV

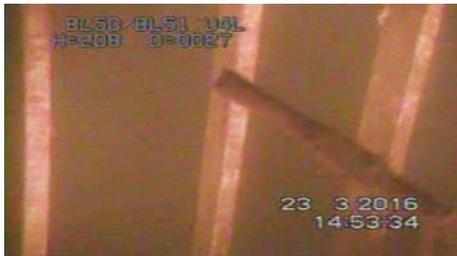
Figure 3. Wooden debris obstructing the downward movement of ROV at EL 528ft.

Operated Vehicle (ROV) proved to be useful. The recorded image can be used for remedial measures of the distressed portion. Scanning of upstream surface must be carried out at regular intervals. Since the debris were found up to the elevation of 530ft it is recommended to clean the trash racks.

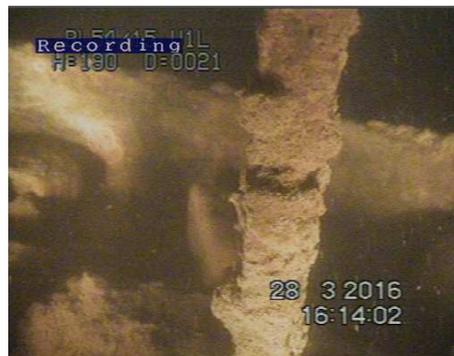
depths. Signs of deterioration/ defect could be seen at few locations. In masonry, the pointing is intact on all over the places where images were captured. The mortar in rubble masonry is not missing in the observed locations. Cracked mortar was not visible. Cavities could not be detected. Algae growth was visible in many places [9] [10]. The concrete portion of the trash racks, that is the slab and columns are generally intact at all depths. Grouting marks could not be observed in the masonry portions. ROV could not be piloted below 530ft elevation due to wooden debris or other obstructions (Figure 3 & 4). In front of the trash racks and at the bottom of masonry portion, wooden branches as debris were visible in many places (Figure 3). Heap of stones were found at EL 522 ft inside the trash racks (Figure 4), which is above the invert level of the inlet of the penstock. No other defects were seen in trash racks. The cross section of the horizontal member of the trash rack looks like I section and the vertical member rectangular. In this I section, stones were found lying at many places in the horizontal members (Figure 5) [10].

Figure 5. Stones found on horizontal members of left trash racks in Unit 1 at EL547ft.

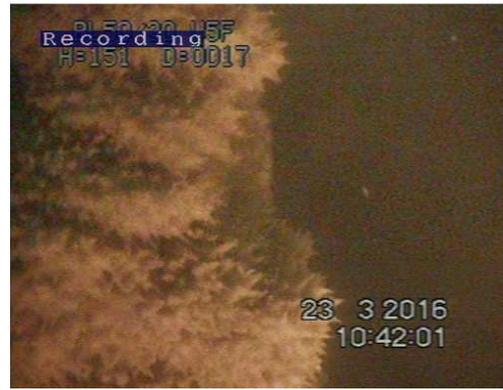
Due to dense algae growth in all the trash racks except unit 3 and 4, identification of cross section of the vertical members was difficult (Figure 5 & 6). In the trash rack of unit 3 and 4, mild growth of algae was observed as these were installed recently. Some trash racks of the Unit 4 were almost free of algae growth. Honey combing in concrete was observed at some locations on both banks (Figure 7 & 8). The observation of the gate grooves revealed anomaly on all gate guides (Figure 9) on the surfaces which are not coming in contact with the rubber seal. From the above images (Figure 7 & 8), the aggregates used in concrete were found to be rounded indicating the use of river bed material.

Figure 6. Heavy growth of algae on the vertical members of trash racks of Unit 5 at EL 561ft.

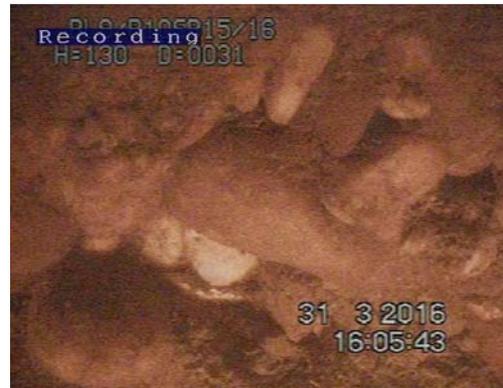
Figure 7. Honey combing in concrete between SB15 and SB16 at EL 513ft.

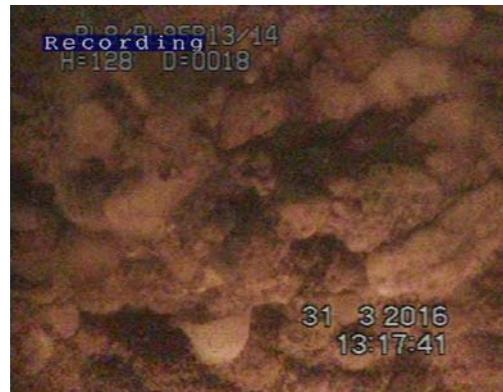
Figure 8. Honey combing in concrete between SB13 and SB14 at EL 556ft.

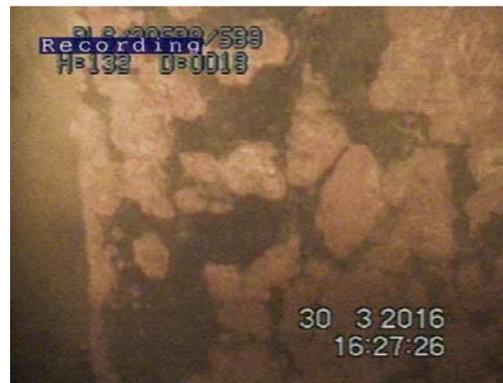
Figure 9. Anomaly on the left gate guide of SB9 at EL 556ft.

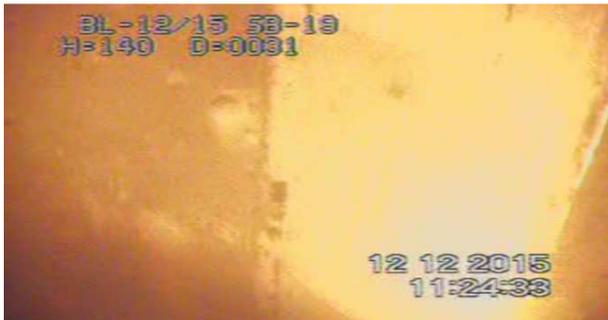
No anomaly can be seen on the locations on the gate groove where it comes in contact (Figure 10) with the rubber seal as the portion where the seal is coming in contact with rubber seal of gate groove is always clean and getting good reflections of light (Figure 10). Good concrete could be observed at many locations even at the deepest as well as at the shallowest levels (Figure 12). Previous intact grouting marks could be observed in many locations (Figure 11).

**Figure 10.** Reflecting portion in gate groove of SB19 at EL523ft.

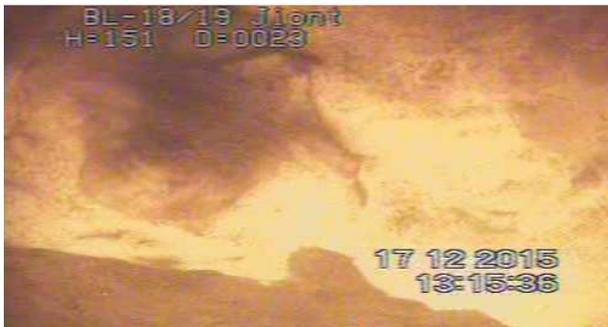
**Figure 11.** Grouting marks seen at EL549ft. On Block 18/Block 19 Joint.
