Analysis and Disposal for Vibration of Vertical Circulating Water Pump

Han Lizheng

Department of Vessel and Machinery, China Chengda Engineering Co., Ltd, Chengdu, China

Abstract: Based on the vibration of circulating water pump in a coal-firing power plant phase II in Indonesia, analysis had been carried out from different aspects for the problem. The key factors concluded were insufficient taper plates and unqualified secondary grouting. Meanwhile, single foundation, high structure above the foundation, higher speed than normal and insufficient structural stiffness were formed the influence factors, which led to the undesirable disposal results. The vibration of 3B was still exceeding 4.5mm/s specified by the standard, 3A was just meeting the value, and the vibration of 4A, 4B was 2.8mm/s. The advice and suggestion had been summarized.

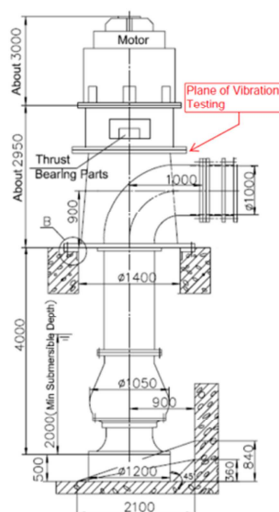
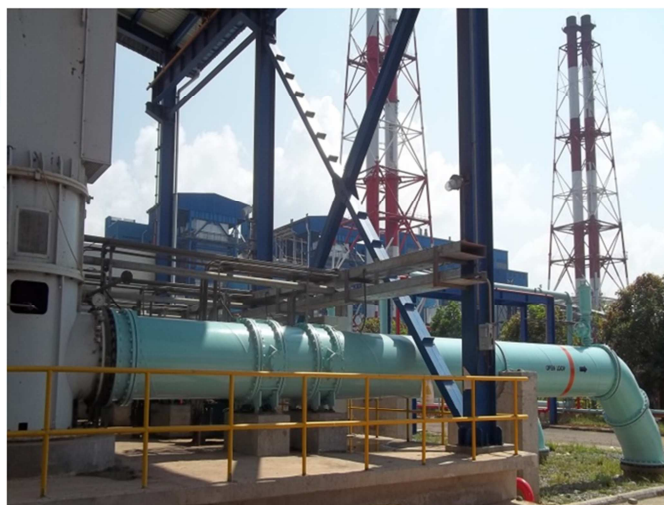
The circulating water pump was mix-flow type, single foundation, discharge above foundation, shaft thrust endured by thrust bearing in pump side (Figure 1).

Figure 1. Circulating water pump arrangement drawing and discharge piping system of phase II.

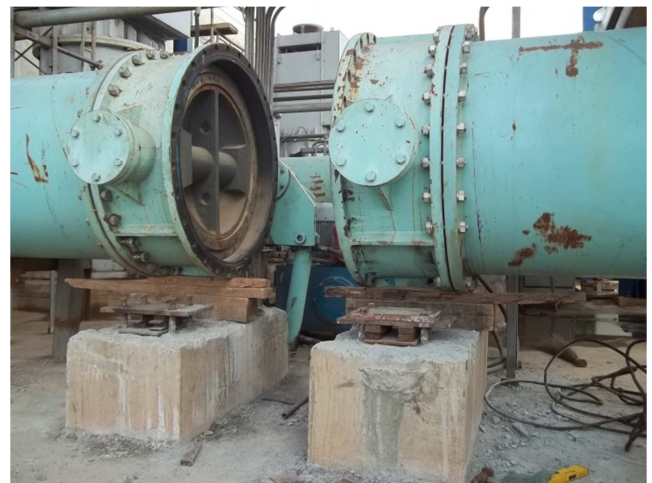
There was a closed relationship between the vibration and the extra force and torque set on pump by discharge piping system [4]. The discharge pipe of circulating water pump was above foundation, and the stress from piping system would set influence on levelness and alignment leading to vibration [5, 6]. The total length of 3B discharge piping above foundation was 9.51m, the top-bottom offset was 64mm and left-right offset was 17mm, which illustrated that the piping system had already set stress on the pump. Then, the modification of 3B discharge piping system was carried out in order to eliminate the stress. Detail method was adjusting each flange connection from pump discharge to underground pipe (Figure 2). There should be no extra torque set on flanges during tightening the bolts, which could be confirmed from the dial gauge set on the

Besides, the length between circulating water pump discharge flange and hydraulic butterfly valve was 2m, and the nominal diameter was DN1100. The pipe was restricted by pump body and the support of hydraulic butterfly valve, which meant that the pipe would set extra force and torque on pump. Comparing to phase I, the length between circulating water pump discharge flange and hydraulic butterfly valve was no more than 1.5m, and there was another support near flexible joint. The restriction of circulating water pump discharge piping system of phase I was similar with “wall pipe” which was normally applied to the circulating water pump with discharge under foundation. The radial and axial restriction of wall pipe was better than phase II. So, under the dynamic condition, whether the extra force and torque generated by both water flow and discharge piping system of phase II would cause vibration, some more research and experiment should be necessarily needed.

Figure 2. Modification of 3B CW pump discharge piping system.

When the modification of discharge piping system was complete, the vibration value of 3B was reduced to 6.2mm/s in mechanical running, which meant the stress caused by offset would affect the vibration, even it was not the major impacting factor.

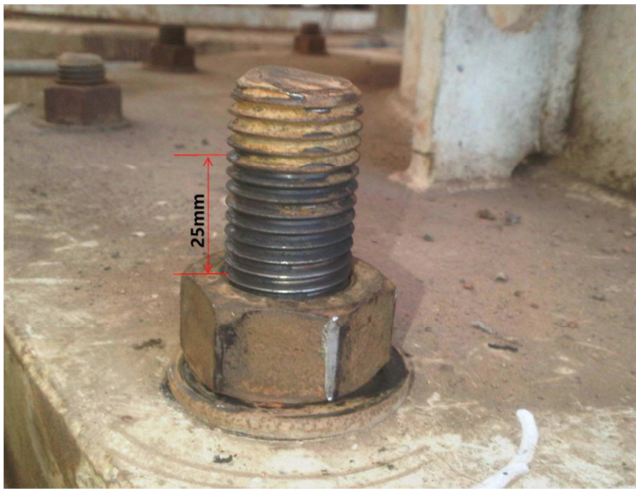
One anchor bolt was drawn out during the leveling and commissioning of 3B, because the anchor bolts had been tightened and loosened repeatedly. The anchor bolt was up 25mm (Figure 3) and the others were checked one by one and most of them were drawn out with different lifting length. Secondary grouting was found unqualified when foundation was cracked, including: secondary grouting was divided into two periods while it should be continuous, the two grouting layers were well-defined and there were much sundries, dust and sand between the two layers, which should be cleared up

before grouting. Most of anchor bolt holes were still half empty and filled with support materials while the secondary grouting had been completed. That was why the anchor bolts could not be fixed firmly.

Figure 3. One anchor bolt of 3B drawn out.

Besides, the taper plates set under leveling plate were not enough. According to the Installation Manual of Circulating Water Pump [11], there should be 32 sets taper plates for each circulating water pump. However, only 8 sets were installed actually in situ. That the surface of 3B leveling plate was found irregular measured through level meter before cracking the foundation, should be closely related with the insufficient taper plates, unqualified secondary grouting and repeated mechanical running.

All foundations of 4 circulating water pumps were cracked and reset 32 sets taper plates under leveling plate. The anchor bolts were spot welded with steel bars embedded in the foundation in order to fix them firmly (Figure 4).

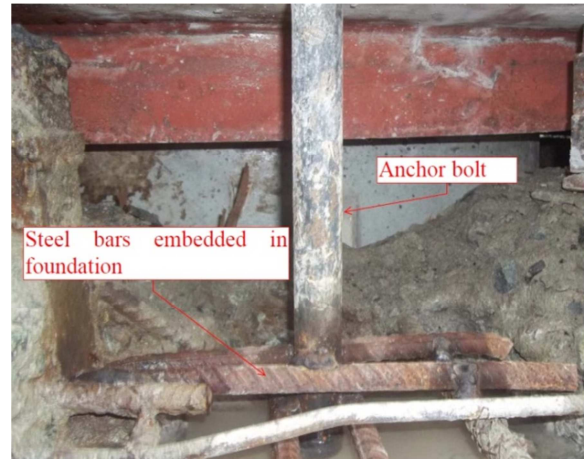
Figure 4. Anchor bolt was spot welded with steel bars embedded in foundation.

When the modification of foundation was complete, the vibration values of 3A, 3B were 4.3mm/s and 4.8mm/s, which could prove that insufficient taper plates was another major influence factor of vibration.

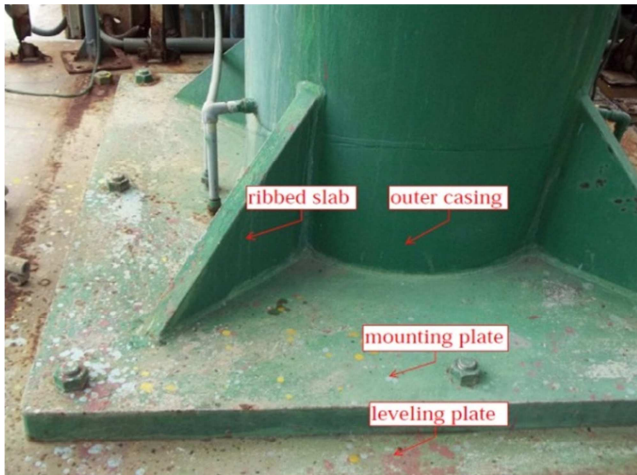
the thrust bearing was on motor side and the height above foundation was much smaller than phase II. The pump and motor was lighter than phase II, while the thickness of mounting plate was much thick than phase II (Figure 5).

Figure 5. Outer casing and mounting plate of circulating water pump in phase I.

which was similar with phase II. The solution given in the reference was increasing the thickness of supporting structure, e.g., the thickness of outer casing increased from 10mm to 18mm. The parameters of circulating water pumps of phase I were listed in Table 3. They were also single foundation, but
