Hydraulic Performance Evaluation of Diversion Weir and Canal Structures: Case Study of Basaka Small Scale Irrigation Scheme, Wayu Tuka, East Wallaga, Oromia, Ethiopia

Gemechu Mosisa*, Dereje Adeba

Department of Hydraulic & Water Resource Engineering, College of Engineering and Technology, Wallaga University, Nekemte, Ethiopia

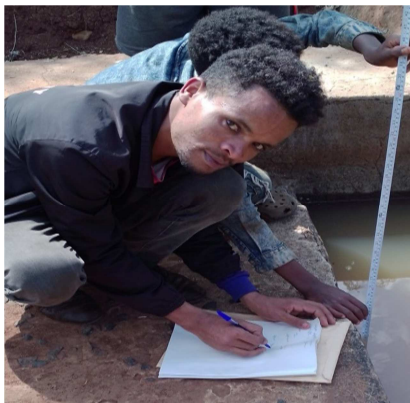
Figure 4. Current measurement of sediment accumulation.

The result presented in Table 1 indicated that 0.75m height of the silt is deposited in the Basaka diversion head-work

structure at the upstream reservoir. This is increasing the river bed level due to sedimentation. Sedimentation on this bed level comes from the catchment area and is stored in the upstream reservoir due to the lack of under sluice gate structure on this weir. Therefore, the weir height was reduced from 1.5m to 0.75m. This sediment deposited in the upstream reservoir causes the failure of the weir & clogging of intake gate water withdrawal after a few years and discontinuing the agricultural process.

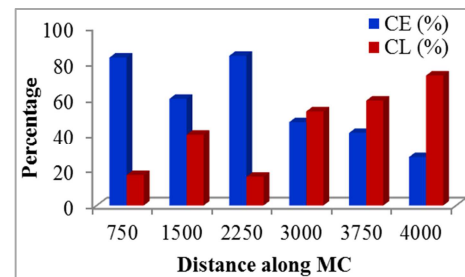
Figure 5. Conveyance efficiency & conveyance loss at MC.

Siltation, breakage of canal, seepage, evaporation, and vegetation growth within the canal interfere with water flow, reducing the conveyance efficiency of the main canal from the required discharge which is 0.3m³/s as shown in Figure 5. According to the FAO guideline cited by [18], the indicative conveyance efficiency of adequately maintained earth canals with loam soils should be not less than 75%.

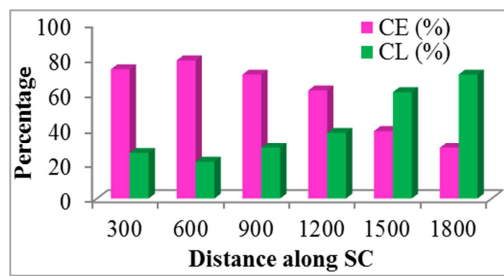
Figure 6. Conveyance efficiency & conveyance loss at SC.

Siltation, seepage, and vegetation growth within the canal interfere with water flow, reducing the conveyance efficiency of the secondary canal from the required discharge which is $0.04\text{m}^3/\text{s}$ as shown in Figure 6.

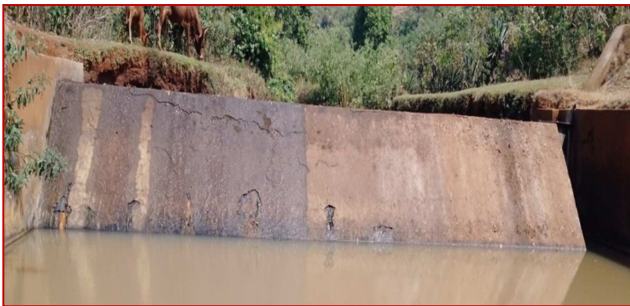
In the case of Basaka diversion head-work, under sluices were not constructed because the river has sediment on my site observation accumulation of bolder and enhancing conflict between users of downstream and upstream of diversion head-work due to no water cannot pass to for downstream during winter season rather than a rainy season (during overflow) as shown in Figure 7. Due to the lack of under-sluice structure, it is difficult to remove the silt from this headwork without human power. Therefore, due to the improper design, this scheme is affected by a sedimentation problem that comes from the watershed area and is deposited in the reservoir of the diversion weir.

Figure 7. Lack of under sluice gate.

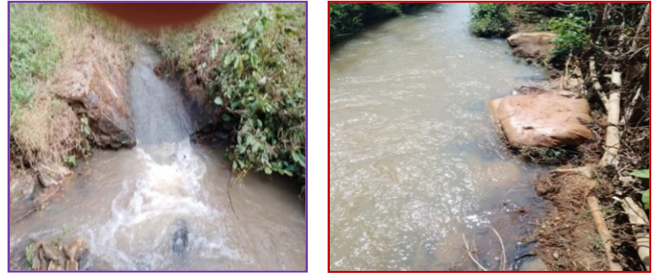
The main canal is a structure that served to transport water from the diversion head-work to the command area. Due to the rupture occurring around the intake structure and on other parts of the command area, it will reduce the efficiency of the scheme. The main cause of this breakage is the conflict between users who getting service from this river based on the required water for downstream. Now, users use this canal by maintaining locally available materials like soil, boulders, and other materials during farming activities year to year as indicated in Figure 8. But those farmers whose daily activity is depending on this agriculture are asked many times for maintenance to go to the Wayu Tuka woreda agriculture and development office. Still, now, there is no maintenance on this scheme.

Figure 8. Breakage of the main canal.

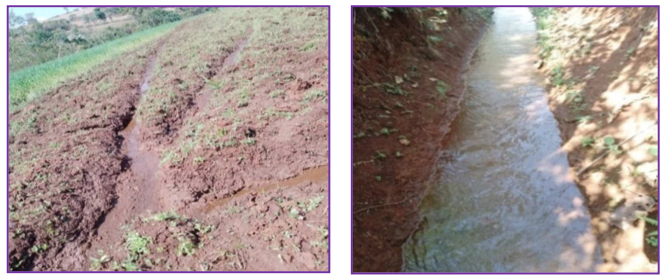
Currently; there is a seepage problem in the main canal and secondary canal structures at the Basaka irrigation scheme. It is difficult to prevent leakage through the main and secondary canals because they are unlined earth canals as indicated in Figure 9. During this time, the researchers recommend that the canals be converted to lined canals for reducing seepage problems by participating both government and beneficiaries from the scheme. If this is difficult; another option is plastering this canal with clay soil before starting the agricultural activity.

Figure 9. Highly seepage due to the unlined canal.

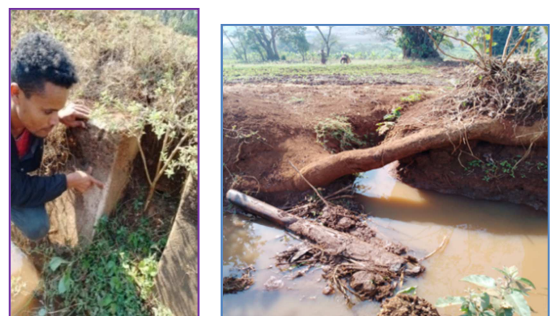
Turnout is the most quintessential phase of canal shape which is used for the divert water to the farming area. Due to this in the Basaka canals structure half of the constructed turnouts are no longer used for the motive they want for construction as indicated in Figure 10.

The scarcity of water occurs throughout the irrigation season and water level cannot attain the hole of turnout which passes water to the agricultural area. At this time half of the farmers use water from the canal by the method of making illegal turnout for serving water for the crops as indicated in Figure 10. But this method is after a few years destructive to this canal if immediately protection can't reach it.

Figure 10. Clogging of turnout structure.

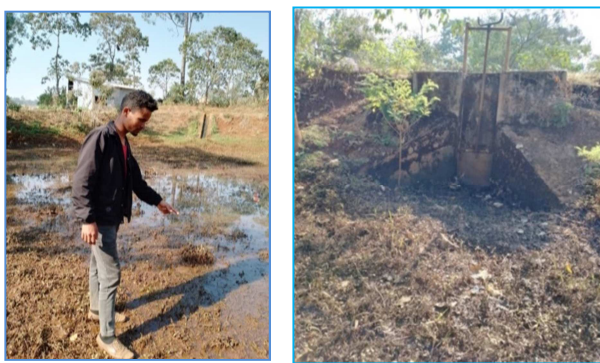
Night storage is a structure used to store water at night and release water for the users downstream of the command area for farming practices like upstream users' command area. But this structure due to the shortage of water the structure does not give the service for which constructed. The scarcity of water problem comes from breakage on the lined main canal around the outlet of the intake structure and seepage problems in the unlined main canal as shown in Figure 11.

The scarcity of water occurs only after the outlet of the intake structure. These indicate that water diverted from the river is to meet the demand of the command area. These issues decrease the performance of the Basaka diversion scheme. Therefore, to enhance the performance of the scheme must maintain the breakage lined-main canal with concrete or masonry and convert all parts of the unlined canal to the lined canal to minimize seepage through the canal totally by considering evaporation loss.

Figure 11. Night storage problem due to scarcity of water.
