Interference Fringe Patterns in Documentation on Works of Art: Application on Structural Diagnosis of a Fresco Painting

Vivi Tornari¹, Anastasia Tsigarida², Varvara Ziampaka², Fotini Kousiaki³, Eleni Kouloumpi⁴

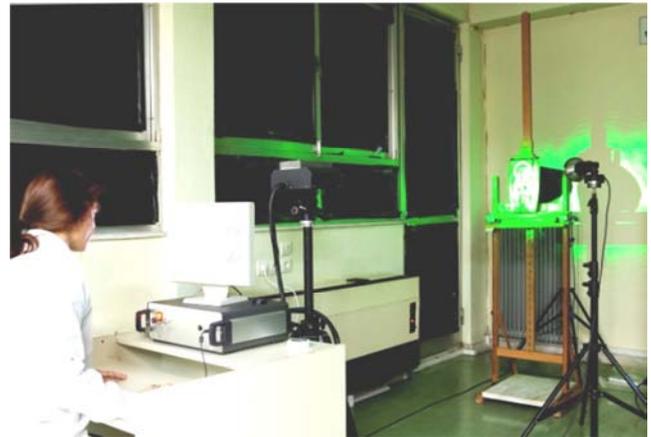
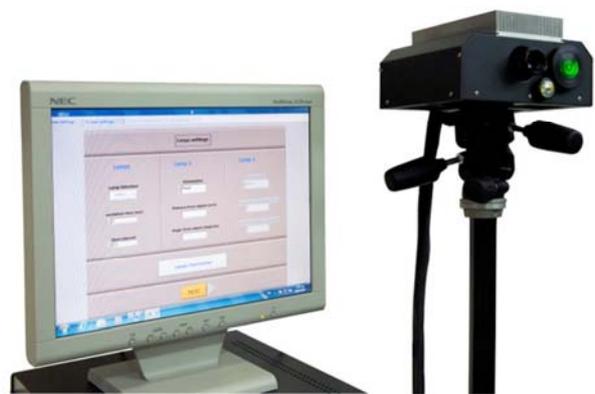
Figure 1. (a) The complete DHSPI II system in laboratory operation, with computer, electronics and peripherals and (b) the laser head on tripod.

DHSPI (Figure 1) is the result of many years of optical holographic interferometry and speckle interferometry research of the author Dr Vivi Tornari from the Holographic Applications Laboratory of the Institute of Electronic Structure and Laser at the Foundation for Research and Technology Hellas (IESL-FORTH) and the capitalisation of several European funded projects to name some LASERART and MULTIENCODE of the same research group under her supervision. The system was custom developed aiming to face everyday art conservation investigation needs. Since explicit presentation of the technique and system is not the aim of this article, the interested reader is advised to seek literature-references [16-24].

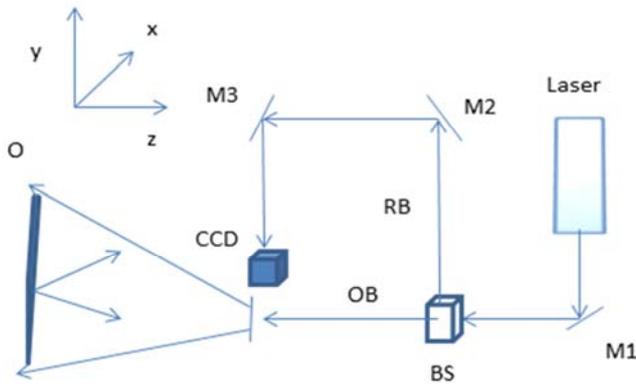
Figure 2. Schematic geometry of DHSP I where M: Mirror, OB: Objective Beam, RB: Reference Beam, BS: Beam Splitter and O: Object.

In DHSPI the interferometric comparison is achieved by two beams of the same laser after amplitude modulated beam splitting providing the two arms of an interferometer from which one is mirror-driven and collimator-expanded to illuminate by a controlled divergence beam the surface and

be scattered by it. The beam illuminating the object is termed OB (Object Beam) and the other, spatially filtered and collimated, that is used to serve as a reference for the interference phenomenon to take place is termed RB (Reference Beam). As a result, an interference is produced and is collected on a CCD plane to be acquired by a frame grabber and further analyzed by numerical processes via specially developed software. Schematic representation of the DHSPI optical geometry satisfying fundamental holographic interferometry operation principle is shown in Figure 2 [23].

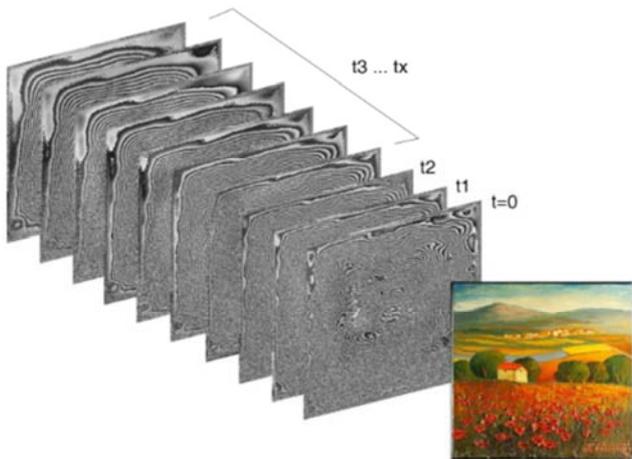
Figure 3. Schematic of the recording procedure where time interval is the time between two recordings: $t_i = t_i - t_{i-1}$.

In regards to the thermal excitation of step 4 the DHSPI system is used to perform measurement of surfaces during displacement and in order to provoke displacement it is equipped with two thermal lamps. The thermal excitation of the surface is achieved by a thermal loading directed to the surface. In this case the induced transient thermal excitation, due to the nature of the physical processes involved, excites the surface, subsurface and bulk provoking a most effective visualization of the overall condition. This type of excitation is safe as long as the surface deformation does not exceed the resolution range of N counting up to few tenths of microns. The typical thermal loading regime necessary for the required displacement is the increase of the surface temperature within the range of a minimum of 0.5-1°C to a maximum of 3°C, an alteration acceptable considering that it lies in a much lower range than the uncontrolled seasonal or daily fluctuations in museums and galleries on the level of $\Delta T \approx 5-8^\circ\text{C}$ [11]. After the thermal excitation is terminated, the natural cooling process of the object takes place and sequential or single recording begins. The recorded data are interferograms visualizing in intensity variations the surface displacement at specifically determined time intervals (Figure 3).

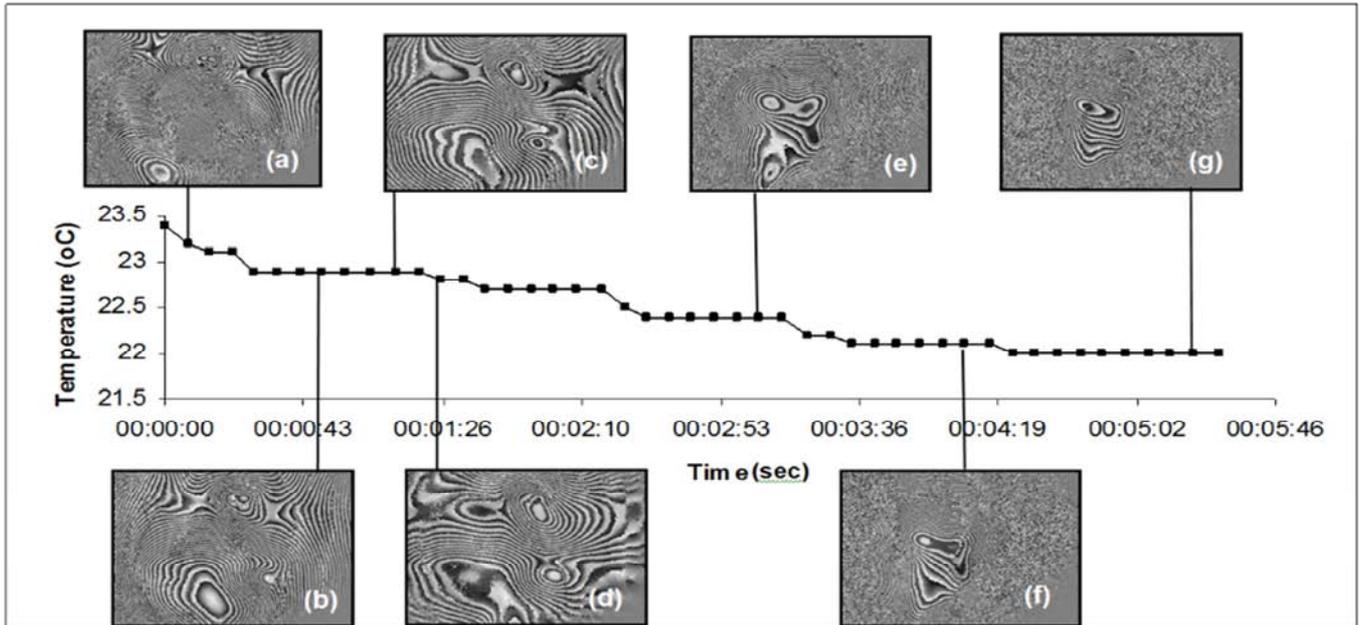
Figure 4. The cooling down process after thermal excitation of the surface. (a-g) interferograms recorded on specific intervals.

The displacement effect of thermal loading is added on the diagram in Figure 4 especially for the case of fresco fragment attached on framed canvas support. Canvas consists a high-

hygroscopic and vibration-responsive object, consequently thermal excitation contributes to a great number of interrelated fringe systems. In Figure 4 an exemplary result of the cooling process of the attached fresco-canvas combination is shown. The dense fringes representing the dimensional reaction of the surface during cooling down at variant experimental times suggest that the reaction of the surface is very intense. The observation is confirmed throughout the cooling down process. The dense fringes signify a strong displacement. The reaction corresponds to the unstable canvases behavior [15].

The interferograms (Figure 4) highlight the reaction of the surface in interaction to inner layers and canvas during time; starting with the surface visualization towards inner layers and the bulk. Areas with localized fringe patterns are observed throughout the process. These carry information on structural anomalies, as cracks and detachments, displaced in different density from the rest. The qualitative processing implies collection of the coordinates of the repeatable localized reactions to locate the centers of anomalous displacement generation corresponding to existing structural defects. The fringe density remains strong and longer cooling down time is required for the strong reaction to cease.

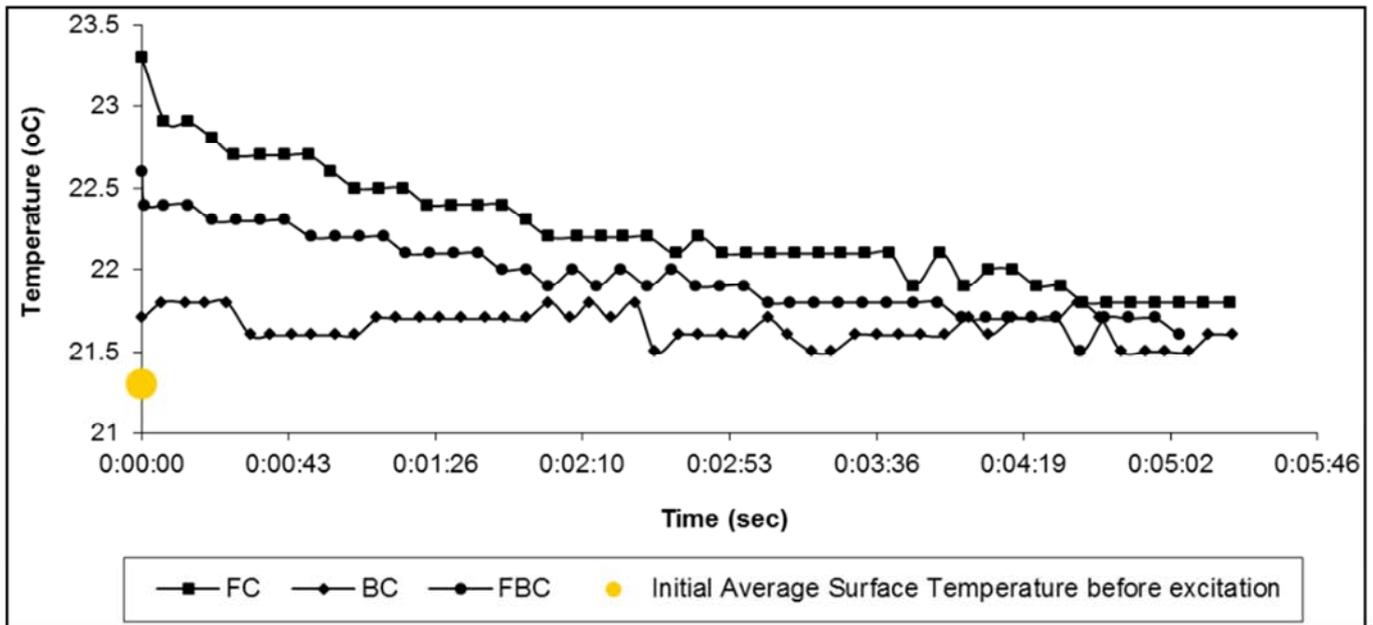
Figure 5. Exemplary cooling process of the fresco for FC, BC and FBC.

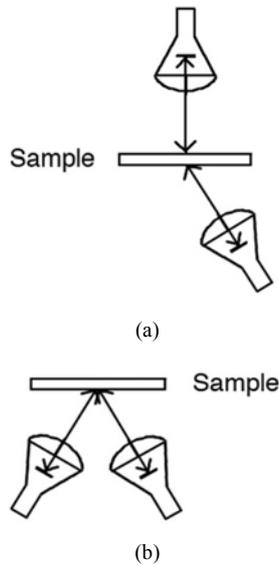
Figure 6. Configuration set up: (a) Front-Back, overall excitation and (b) Front or Back.

The necessary alteration of the investigated object is given by two IR lamps equipped as peripheral instrumentation the DHSPI system. The IR lamps are placed according to the configuration chosen. In this study three configurations were applied: Front (FC), Back (BC) and Front-back configuration (FBC). In the first two configurations the investigated object is thermally altered only on one side either front (surface, front view) or back (rare view). In the FBC the object is overall illuminated, both front and back (Figure 6). In any case in order to achieve uniform excitation the IR lamps should be placed in smoothly overlapped beam position.

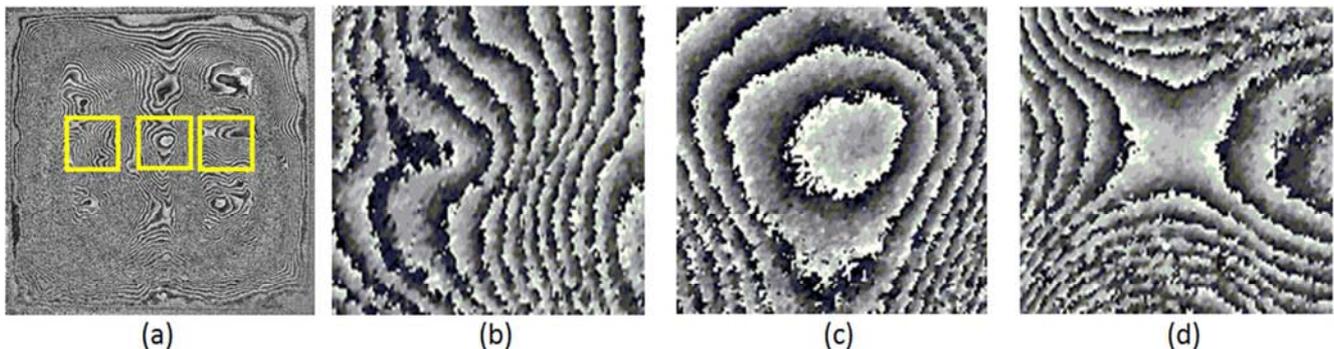
Figure 7. Fringe patterns of holographic interferometry manifest in symmetrical scale-less forms, in a) whole body displacement and in b-d) zooming in local defects as manifest in b) for hidden propagation, in c) detachment and in d) for crack.

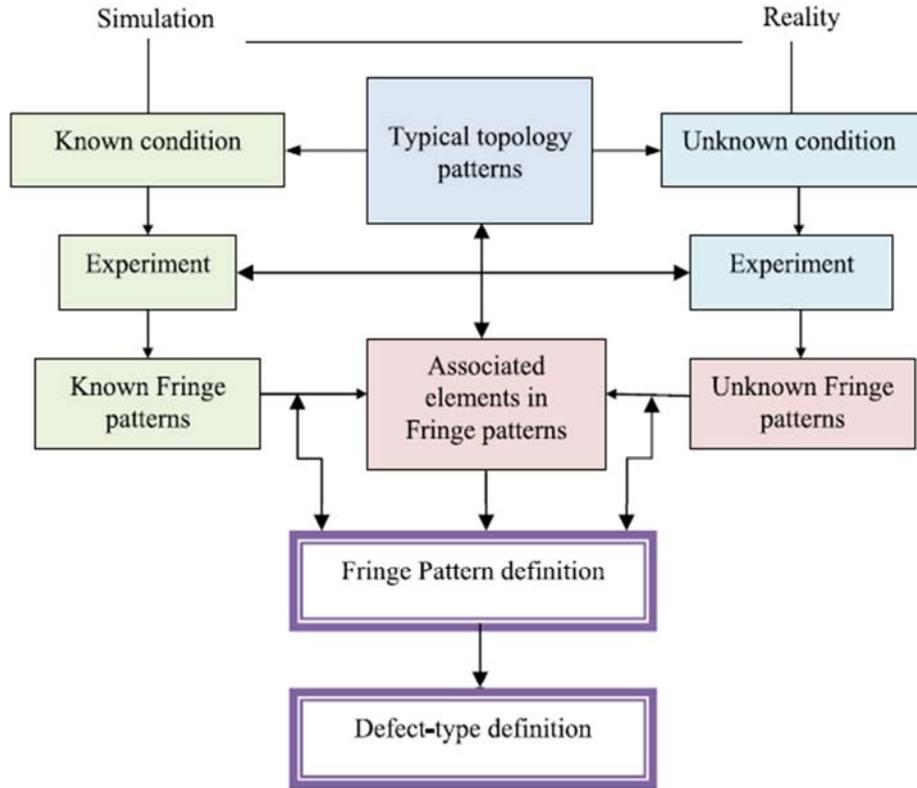
Figure 8. Interconnection Scheme of stepwise procedure to validate defects through unknown fringe patterns in artwork documentation.

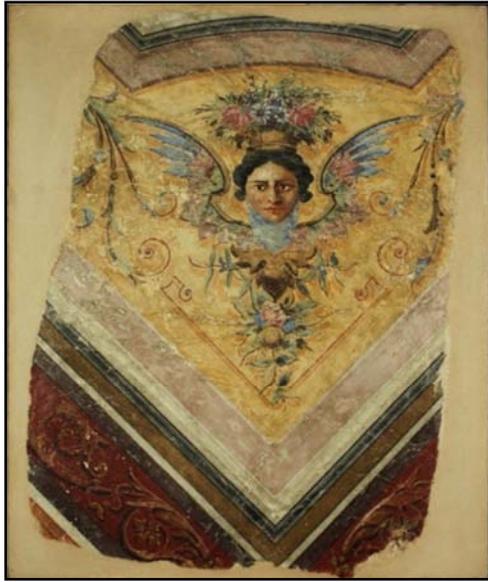
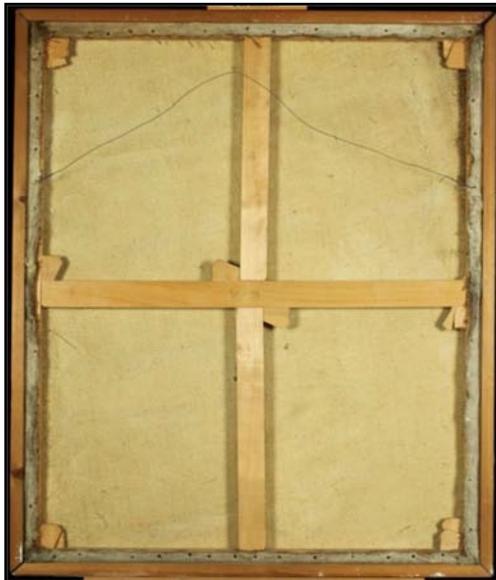
The investigated subject is a fresco and belongs to a private collection (Figure 9). Although there is insufficient evidence for the origin of the object it is likely to have been a ceiling painting i.e. part of the decoration of a ceiling. The last layers of mortar have been detached from the ceiling and fastened onto a linen cloth and a wooden frame.

Figure 9. Object of study: (a) front view, (b) rear view.

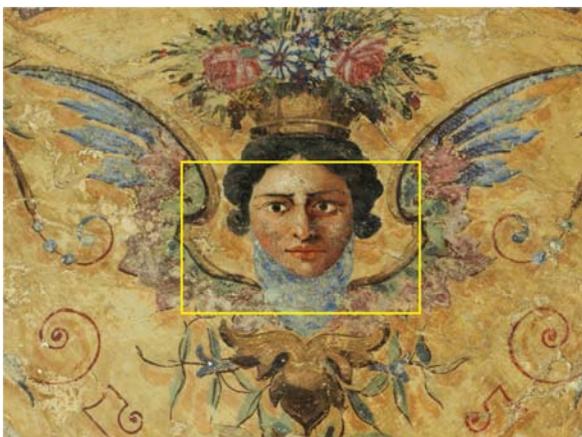
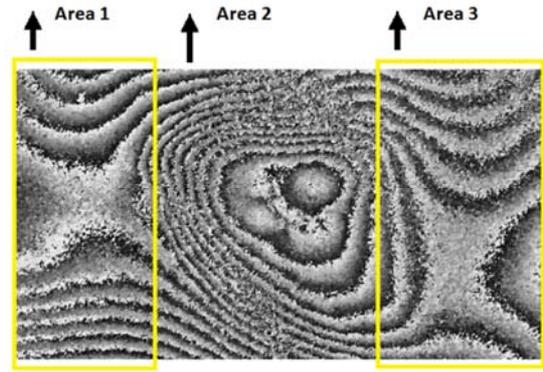
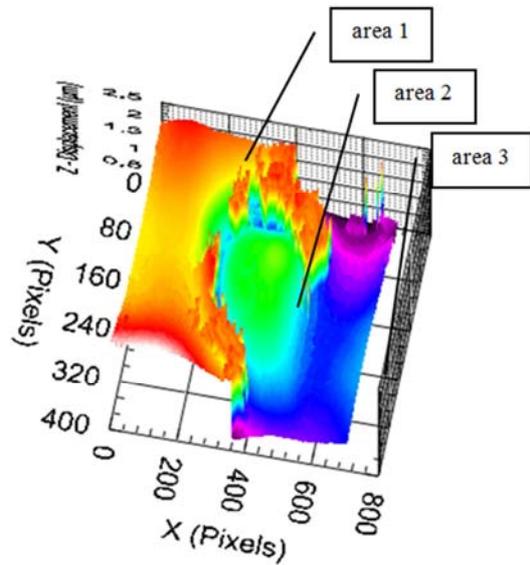
Figure 10. Exemplary of how structural information is assessed: (a) investigated area in the yellow box, (b) interferogram view and in (c) 3d view.

The object is examined by all three configuration types suggested in this study (FC, BC and FBC) and the resulting interferograms are analyzed for structural information of the subsurface. In order to investigate the structural mechanical condition and to detect defects on the fresco an analysis of three stages is performed. Initially, each interferogram is analyzed in individual areas of interest. Each area of interest is recognizable as it forms a local discrete appearance consisting of one or more distinguishable fringe patterns and it can be confirmed by 2d and 3d maps constructed by the system's software (Figure 10).

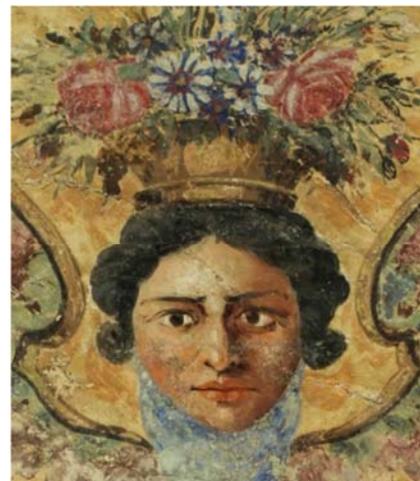
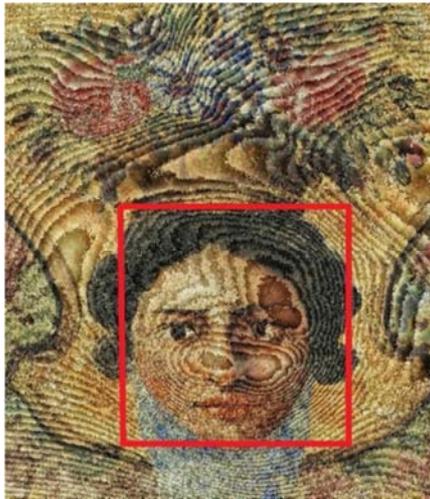
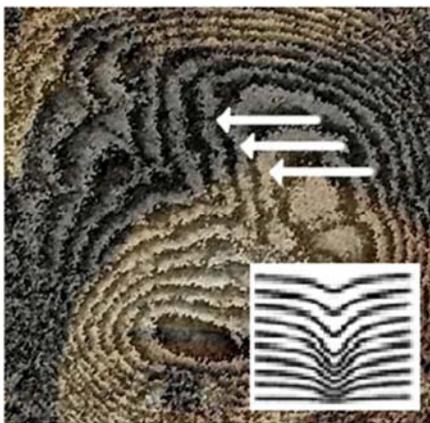
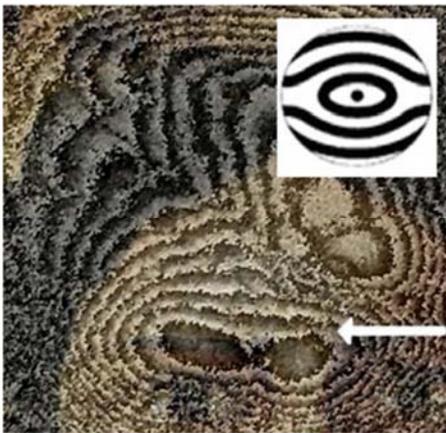
Figure 11. In (a) The investigated area of the fresco, in (b) an exemplary interferogram of the fresco and selecting the area of interest in red box, in (c, d) a characteristic detail of local curved fringes discontinuity and a detail of local discontinuity identified as circular fringes. The formation represents crack with lateral multiple detachment growth.

Then, each region is isolated and the fringe patterns are located. An example of the first two stages of fringe classification is given in Figure 11. The classified fringe patterns presented on Table 2 are used.

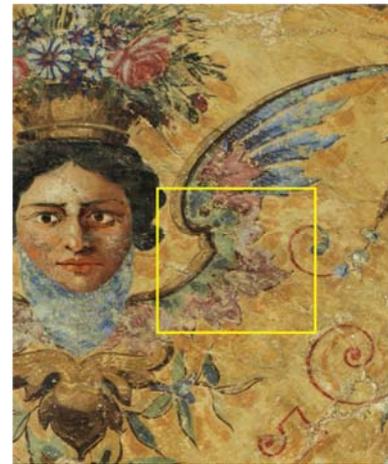
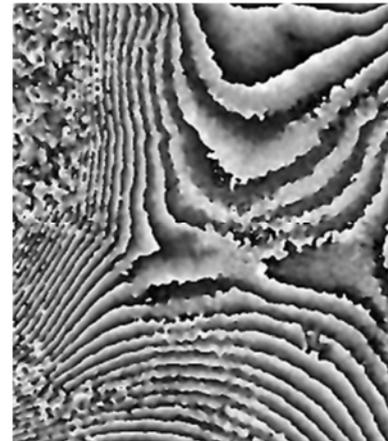
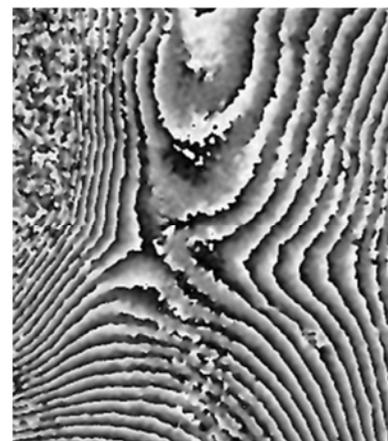
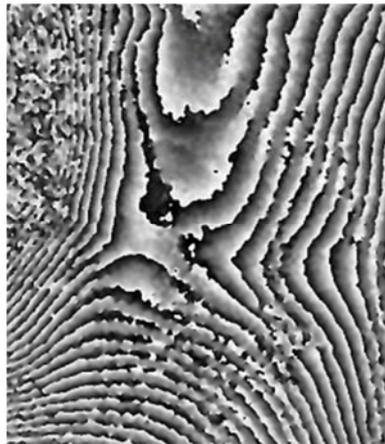
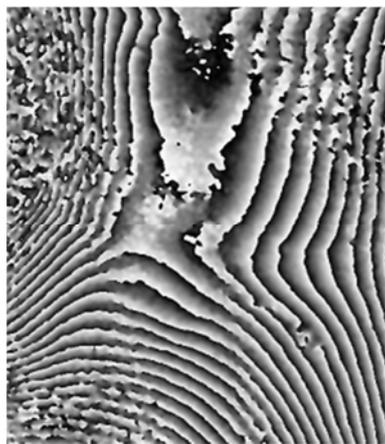
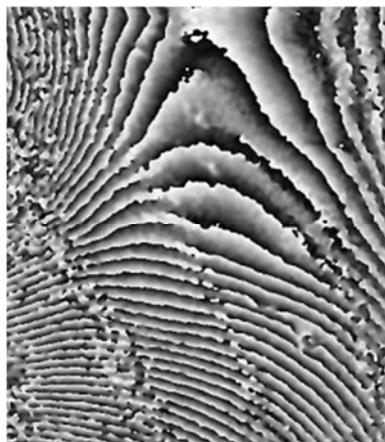
Figure 1. Saddle formation of the investigated area shown in the yellow box (a) over time for (b) $t=13s$, (c) $t=24s$, (d) $t=48s$, (e) $t=70s$ and (f) $t=141s$.

formations with strong presence and persistence in time. Figure 12 shows an example of a saddle formation appearing first time at $t=6s$. It remains present in a stable form and unaffected by the adjacent formations until $t=77s$. The specific formation persists over time suggesting a laterally stressed area of high defect interest for conservators. It took ≈ 70 seconds for a saddle shaped deformation to appear and disappear visualising and indicating the deformed shape of displacement for the areas 1 and 3 of fig10b.

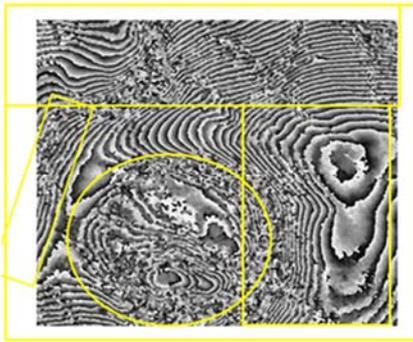
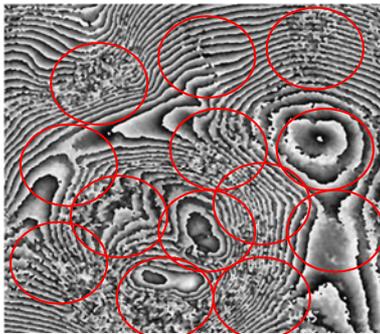
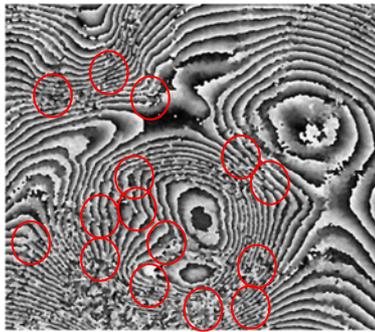
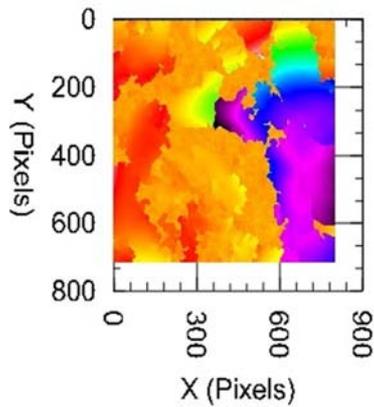
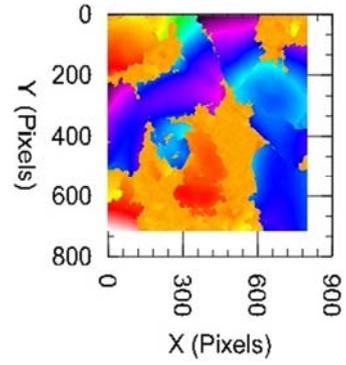
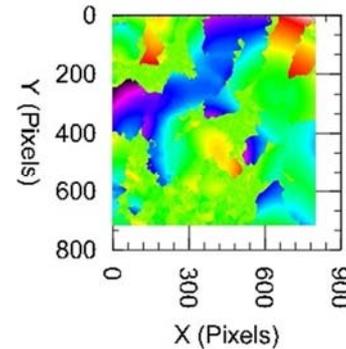
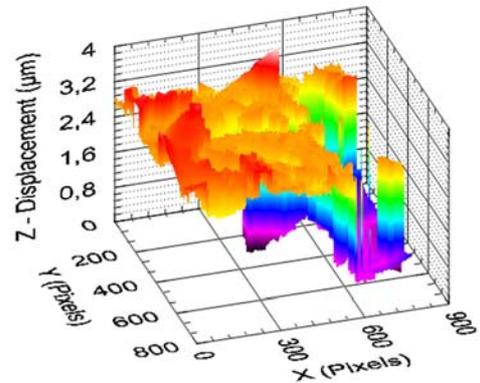
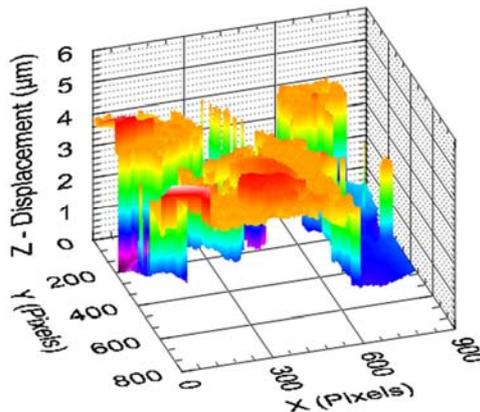
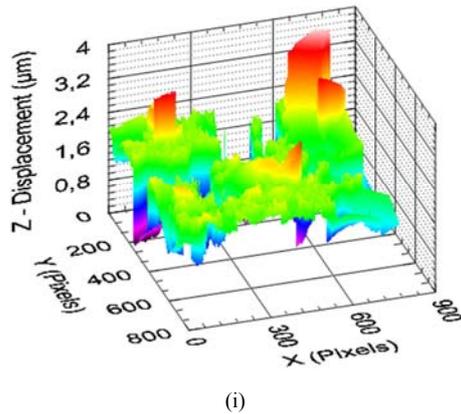
Figure 13. In (a-c) exemplary interferograms for $t_1=41s$, $t_2=106s$ and $t_3=156s$, in (d-f) the 2d surface for t_1 , t_2 and t_3 respectively and in (g-i) the 3d images with the z-displacement for t_1 , t_2 and t_3 respectively.

b) Front excitation: The examination of data from the front surface examination revealed three scales of defect interconnection. There are a) largely expanded deterioration centers covering the painting all across surface, within which exist b) smaller scale multiple localised defects and in many of them include c) locally intense microdeformation structures. These deformation centers propagate and interact enhancing in locally strict defined areas the degradation of materials and promoting the overall surface degradation. As such the image of the front surface manifests high magnitude of local defects indicating strong front surface deterioration. In addition it is important for restoration strategy that the painting surface is divided in centers starting of those of large regions as in yellow boxes in fig 13a, in which deformation covers significant surface area as seen with sparse and dense spatial distribution range of fringe patterns that generates clear divisions in the interferogram image. Hence, larger but sizeable areas of the valuable surface exhibit diverse reaction to thermal impact. These areas are expected in future times to be exacerbated if the cause of the trends not addressed by experienced conservator. Emphasis of the analysis is given to the central theme of the painting (the depicted face) which proves to be a separate, with clear limits, area of intense defect overlapping where cracks generate detachments and detachments generate cracks (Figure 13 a-c). Expanded fringe systems are easily distinguished in fig 13a and correlated to the painting areas, then local defects fig 13b including microdeformation systems fig 13c are extracted, as it is shown by yellow and red circles in Figure 13a-c. In the figure 13d-f, after the wide regions including smaller interconnecting defects are extracted, further temporal elaboration to distinguish microdeformation shapes as rise with time within the previous areas can be performed. The color 3D map can be overlapped to the painting to highlight the final diagnosis result (fig. 14c). The revealed complex defect system is assigned to past restorations and the intense deformation suggests a condition that new defects are or would soon be formed. This conclusion is synthesised by the evaluation of the temporally consistent fringe patterns which are considered existent defects as compared to trends of fringe patterns as they propagate with time which are considered as inborn defects. It is common to observe long term

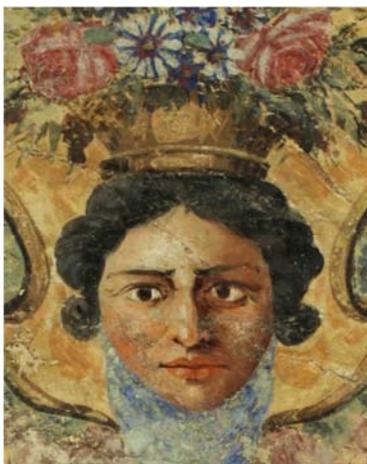
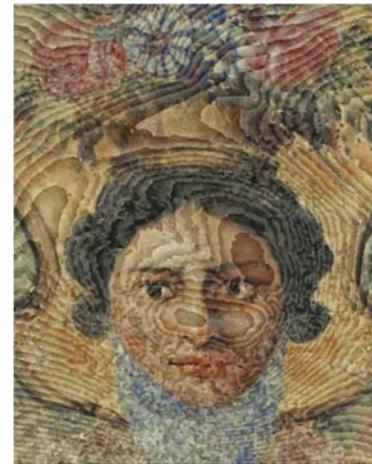
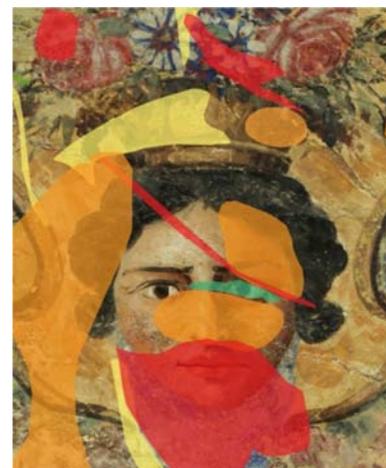
detachment internal crack surface crack trends

Figure 14. In (a) the central theme of the fresco, in (b) an overlapped exemplary interferogram and in (c) the Risk Assessment Map.

Finally a risk priority defect map is synthesised and is shown in Figure 14, as has been traced from examination of area 2 figure 10b the central theme of the painting, indicating the positions, shape and size of the existent defects with the colors indicating the type of defect. Priority is given to the deteriorations that persist during examination because it concerns the full thickness and represent defects that affect most the surface. These require immediate care. These are areas that once fixed can stabilise the overall tendency for deformation of the painting. In this context the map is termed risk priority map and can be used as an accurate guide by the conservator to locate the major points of interest during restoration process.
